Damage mechanisms and non-destructive testing in the case of water ingress in CF-18 flight control surfaces

Technical Memorandum

DCIEM TM 2000-098

August 2000

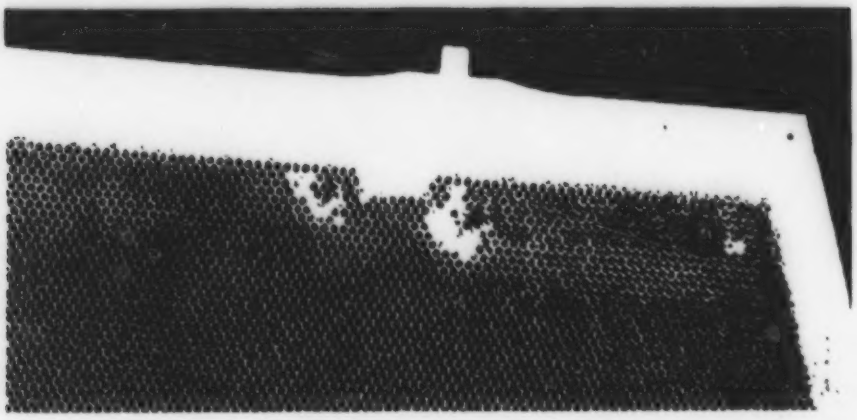
Figure 8. X-Ray inspection results showing water along the leading edge of the rudder.
